**Husky Energy**  
 MUSKWA COMPRESSOR & WATER INJECTION  
 LSD 5-25-84-26 W4M  
 WATER TANKS P&ID

# Storage Tank NDE Report

**Equip Id** 66063009      **SAP ID** 66063009      **Asset Type** Storage Tank  
**Plant** Northwest Alberta      **Unit** Muskwa Booster Stn      **System** N/A  
**Description** TANK, AST, 400 BBL, T-700  
**FLOC** W2-02-010-00005      **LSD** 05-25-084-26W4

**MAGNETIC PARTICLE EXAMINATION REPORT**

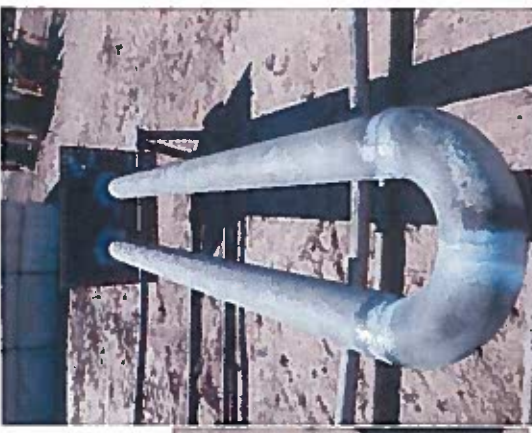
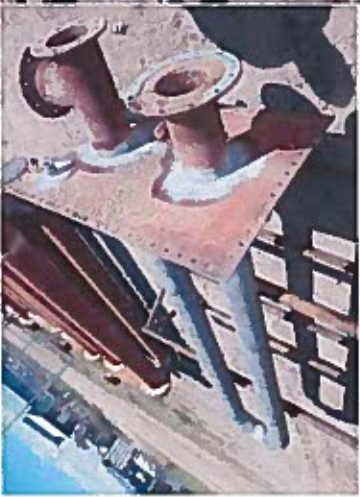
**PURPOSE:** A VISIBLE WET CONTRAST MT EXAMINATION WAS CARRIED OUT ON THE ITEM(S) DETAILED IN THE PHOTOGRAPH(S). NO RECORDABLE INDICATIONS WERE DETECTED DURING THE EXAMINATION. ITEM(S) EXAMINED ARE ACCEPTABLE TO ASME B31.3 CODE.100% VISUAL.

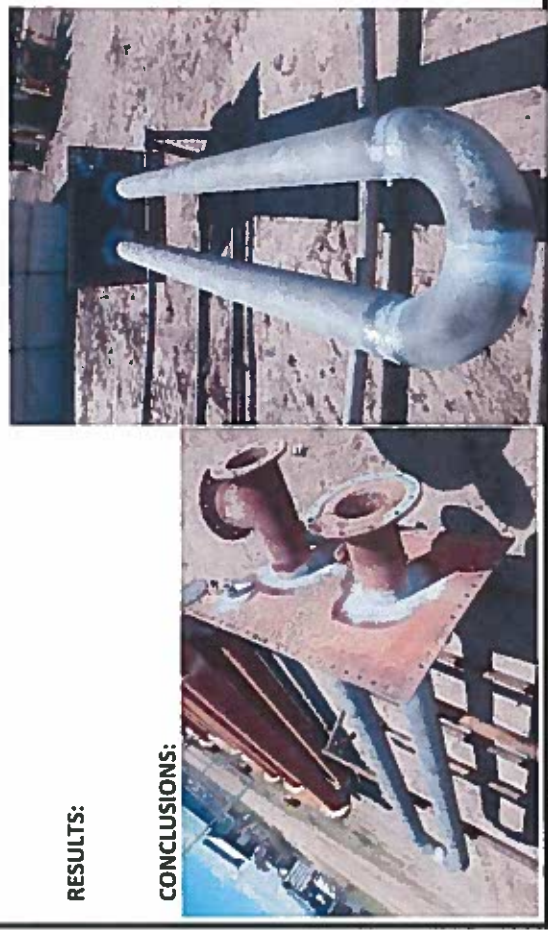
**MT - 0806 - BG**

**PURPOSE:** A VISIBLE WET CONTRAST MT EXAMINATION WAS CARRIED OUT ON THE ITEM(S) DETAILED IN THE PHOTOGRAPH(S). NO RECORDABLE INDICATIONS WERE DETECTED DURING THE EXAMINATION. ITEM(S) EXAMINED ARE ACCEPTABLE TO ASME B31.3 CODE.100% VISUAL.
