TANK INSPECTION REPORT

Report # **TK- ET10AUG2015b**

Inspector: Ed Tymensen,
API 510 #27479, API 653 # 50479

Facility	<u>Drayton Valley</u>	Location	<u>Warehouse / Boneyard</u>	Date	<u>Aug 10, 2015</u>
Serial #	<u>STTK-QJ-T2-15675</u>	PW Equipment #	<u>PWA - 19577</u>	Capacity	<u>400 bbl</u>
Manufacturer	<u>Bilton</u>	Year	<u>2011</u>	Product Stored	_____
Tank Location	Construction <input checked="" type="checkbox"/> Steel <input type="checkbox"/> Fibreglass Other: _____

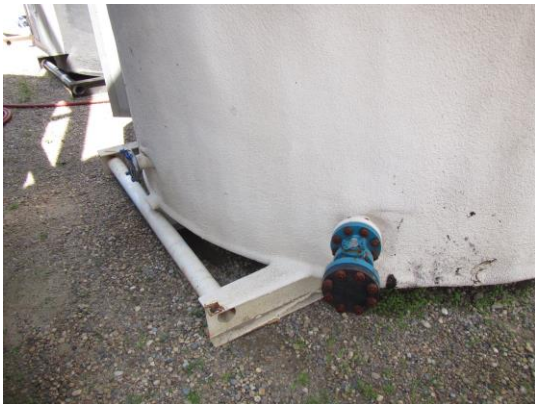
TANK SKIDDED

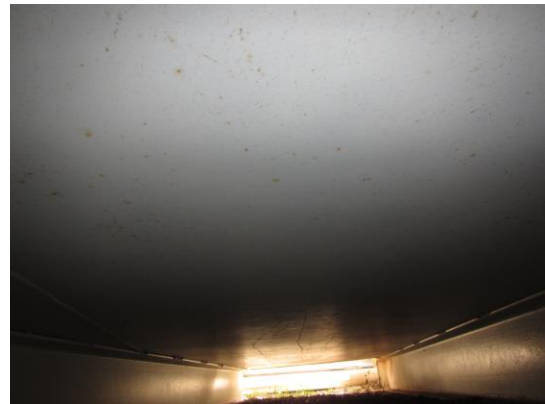
Comments/Recommendations: Floor underside 100% visible. No corrosion or damage noted. Floor topside coated, coating in good condition. No failures noted. UT scans found no evidence of wall thinning.

FLOOR UNDERSIDE

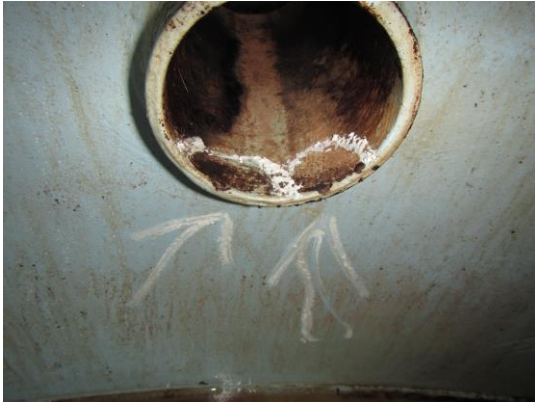
Comments/Recommendations: Nozzles foam insulated externally. Nozzles coated internally. Several small coating failures noted on one nozzle. No corrosion or damage noted internally.

NOZZLE COATING FAILURE

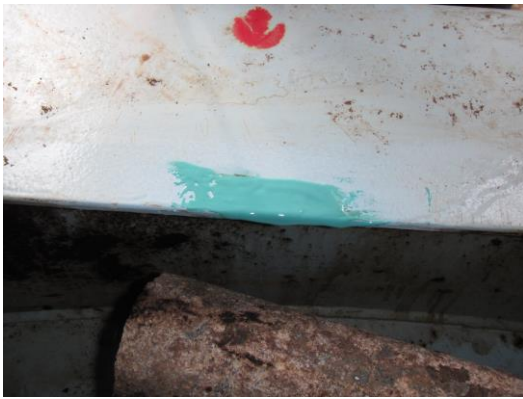
MANWAY COATING REPAIR

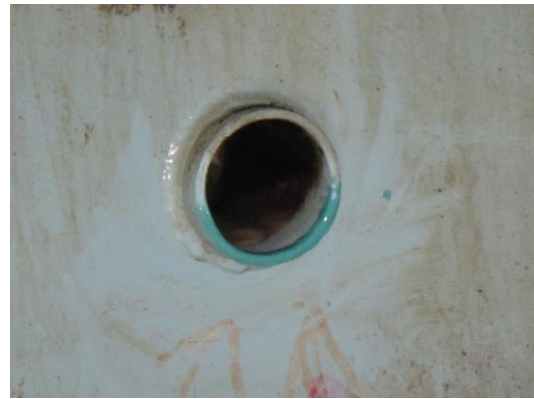
NOZZLE COATING REPAIR

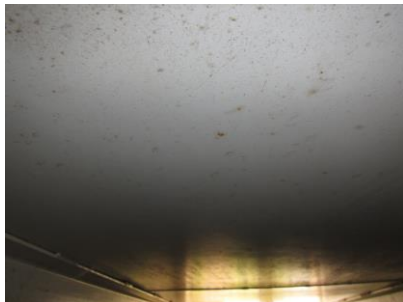
FLOOR UNDERSIDE

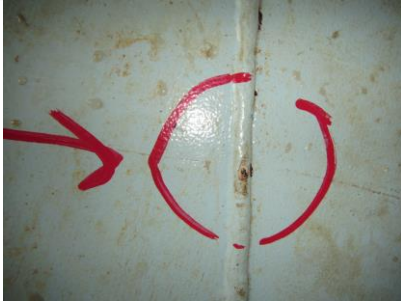
External Condition Satisfactory Unsatisfactory Inspection Not Performed
 Internal Condition Satisfactory Unsatisfactory
 Bottom Plate Projection Satisfactory Unsatisfactory Not visible, foam insulated
 Internal Coating Condition Satisfactory Unsatisfactory N/A
 Floor Leaking? Yes No
 UT Inspected Satisfactory Unsatisfactory UT Inspection Not Performed
Comments/Recommendations: Floor underside 100% visible. No corrosion or damage noted. Floor topside coated, coating in good condition. One small coating failure noted on floor longseam, no corrosion at failure location. UT scans found no evidence of wall thinning.

FLOOR LONGSEAM COATING FAILURE

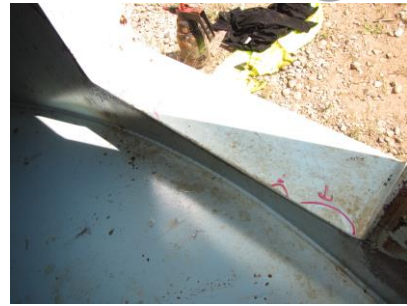
Comments/Recommendations: Nozzles foam insulated externally. Nozzles coated internally. No coating failures, corrosion or damage noted internally. One coating failure on manway found, no corrosion at failure location.

MANWAY COATING FAILURES

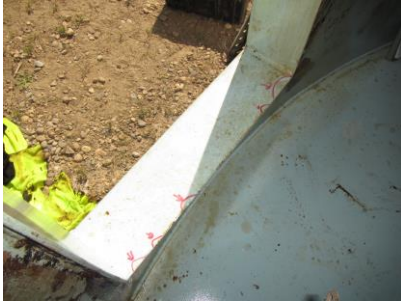
MANWAY COATING FAILURES

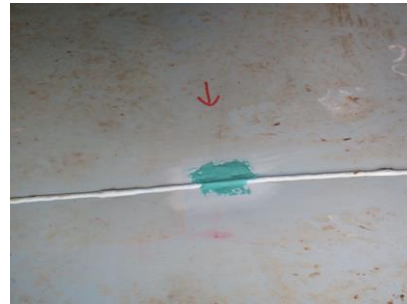
FLOOR LONGSEAM COATING REPAIR

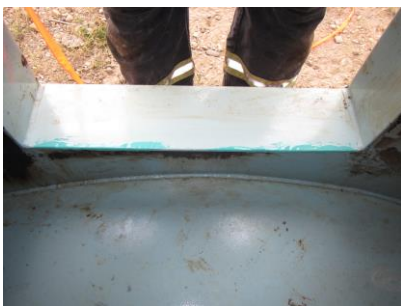
MANWAY COATING REPAIRS
